TECHNICAL INFORMATION #928

ZIB-121

Re: Improvement of RF feedback for the IC706MK2G

Model: IC-706MK2G (All versions)

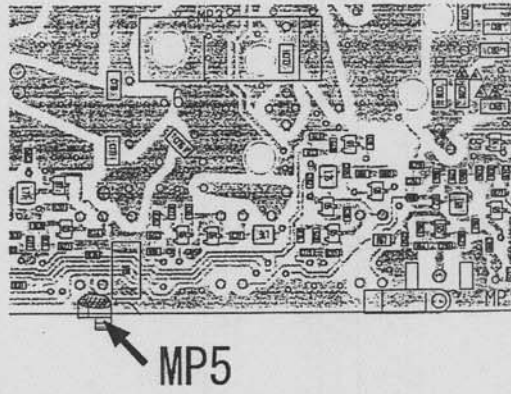
FILTER Board

The RF feedback occurs when SWR condition get worse. This symptom appears on 18 and 21MHz bands mostly at the condition when the SWR is more than 2:1.

- 1) Add the following part on the FILTER board. (See the attached location.)

| Board | Parts Number | Parts Number (Old) | Parts Number (New) | Action Taken |
|---|---|---|---|---|
| FILTER | MP5 | None | 8930055970 | Added |
